August 18, 2015

**RE: Community Paddle Dock and Boathouse
Year 6 Eelgrass Transplant Monitoring Survey (2015)
Protection Island, Nanaimo, BC**

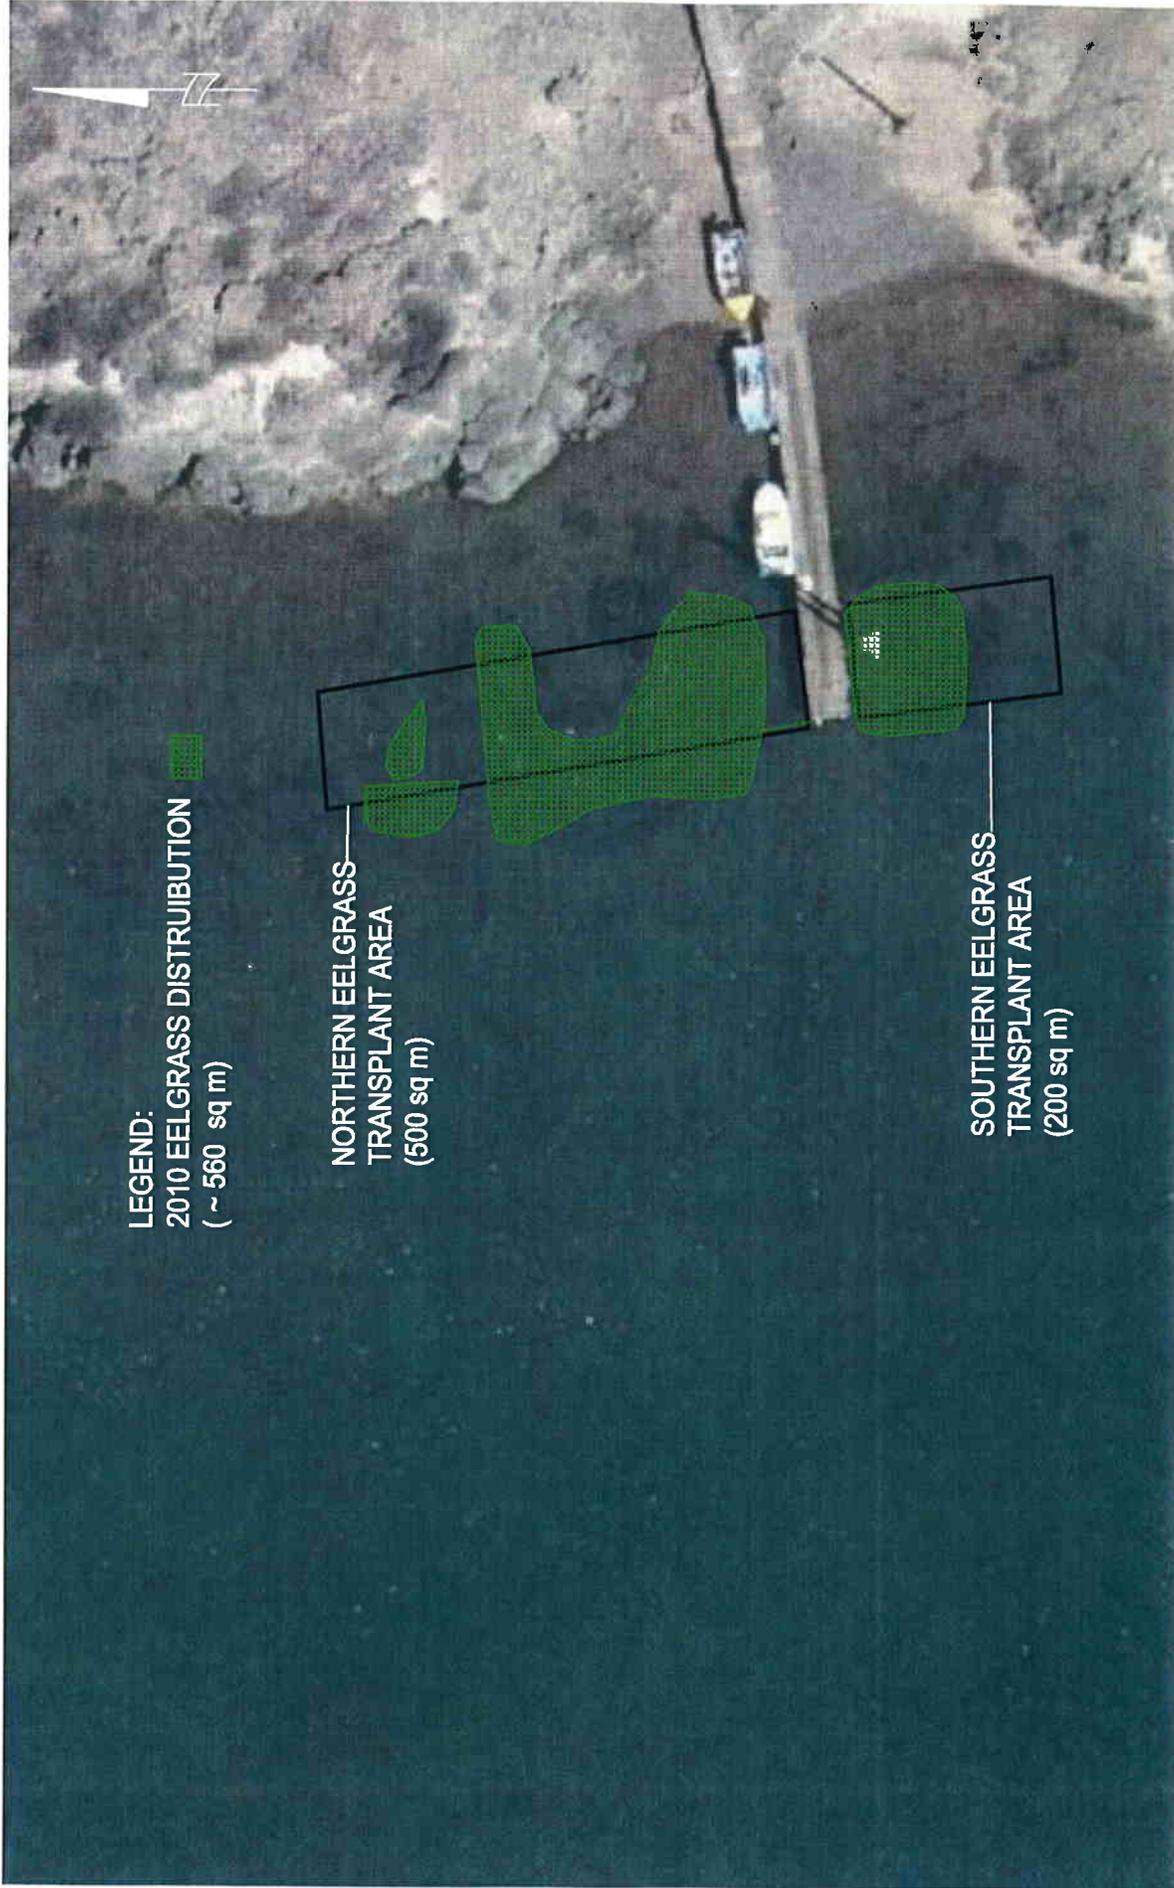
FIGURE 2
EELGRASS TRANSPLANT SITE PLAN

LEGEND:
 2010 EELGRASS DISTRIBUTION
 (~ 560 sq m)

NORTHERN EELGRASS
 TRANSPLANT AREA
 (500 sq m)

SOUTHERN EELGRASS
 TRANSPLANT AREA
 (200 sq m)

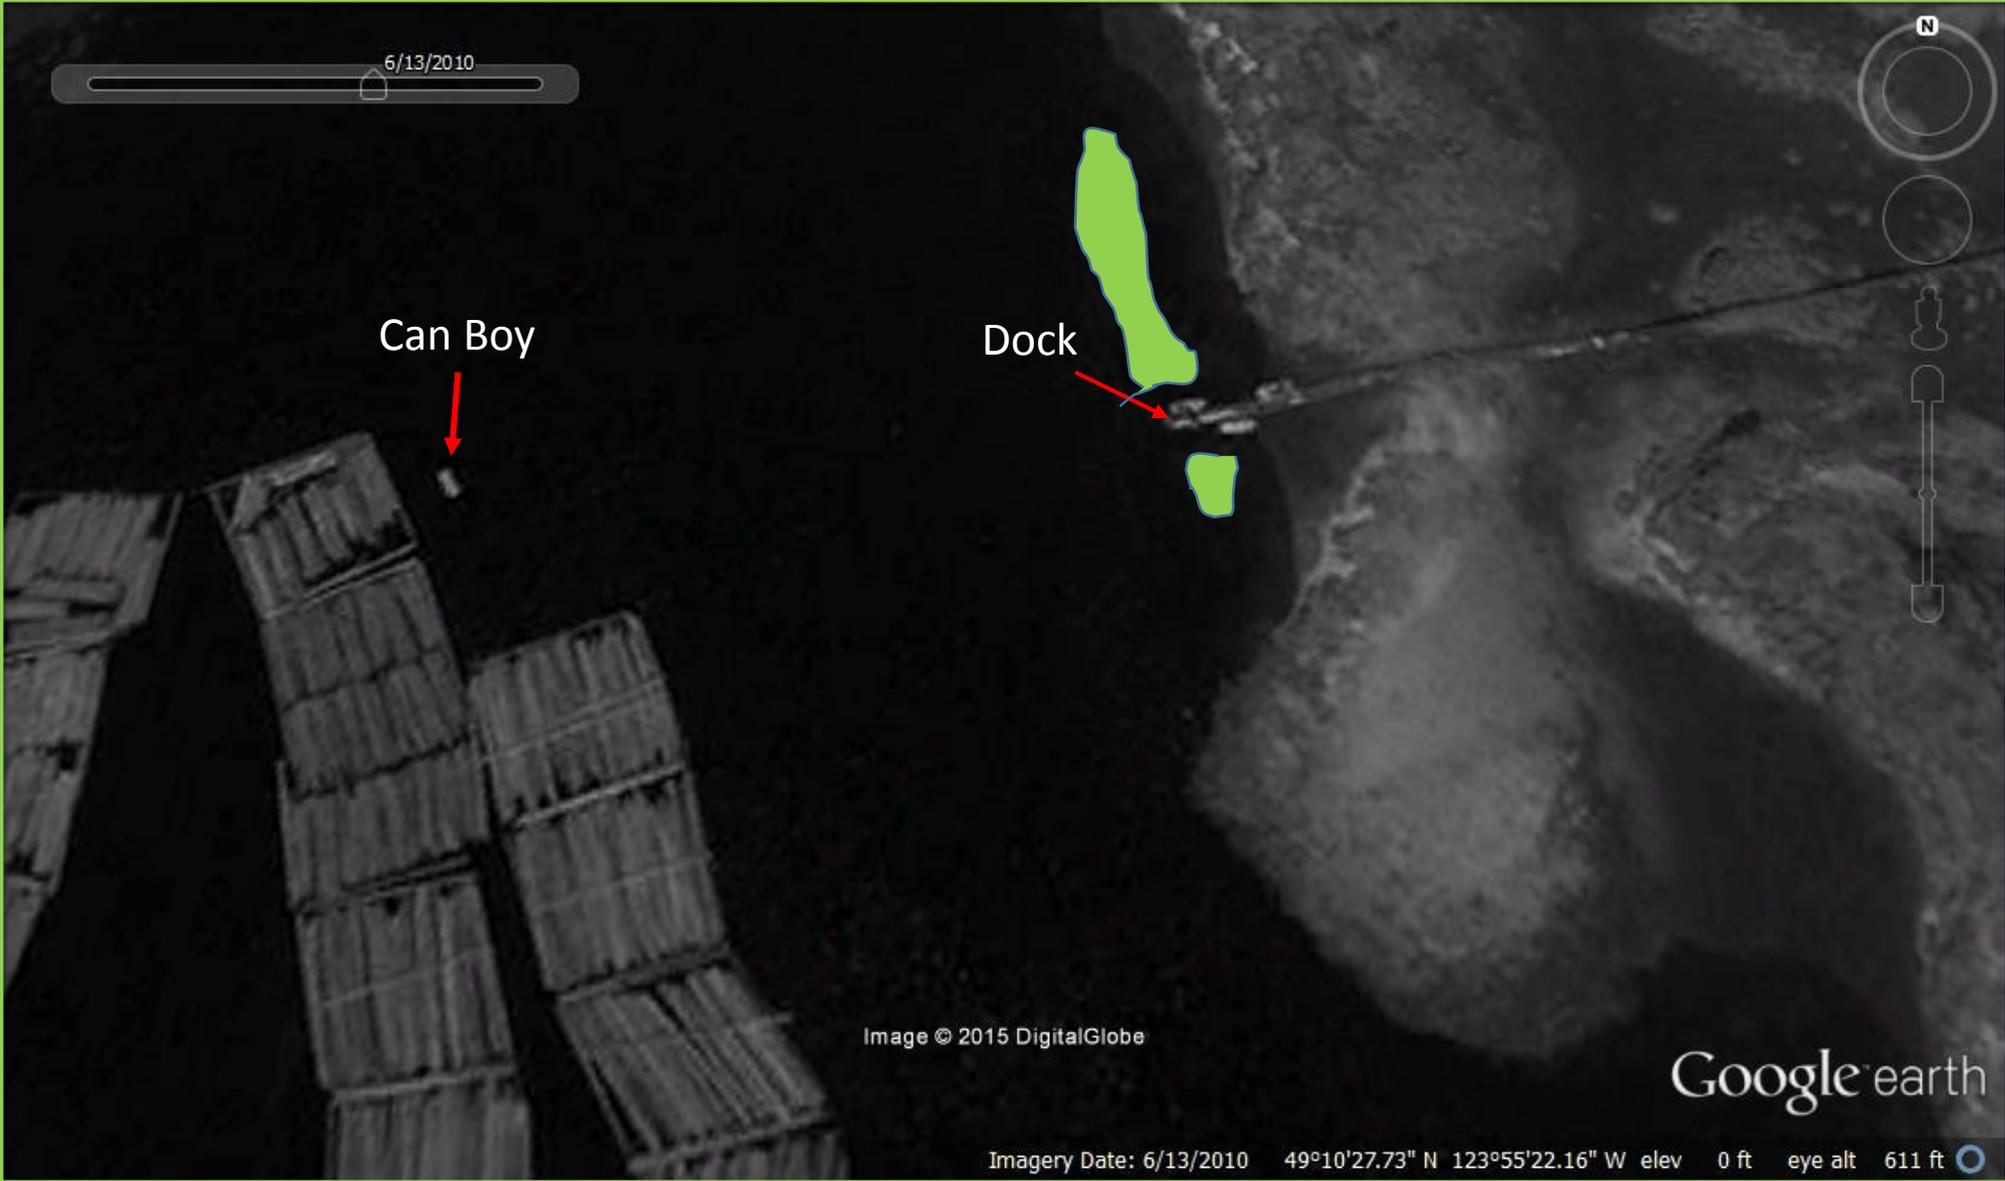
Figure 3A June 2010 Google Earth Image
Eelgrass Transplant Project

Subsequent observations by one of Aquaparian's Biologists a few days after the survey noted boom boats working on the log booms located adjacent to the eelgrass transplant beds. Google earth images of the log booms located next to the dock and transplant beds indicate and viewed over the past number of years indicate that the booms are continually being re-positioned to deal with boom size requirements and that the booms have been active as close as 50m (April 2014 Google earth image) from the docks. A series of Google Earth aerial photo images for 2011, 2012 and 2014 have been included in this report as Figure

Boom boats have a deep keel and powerful engines that have the potential to produce significant propeller wash or substrate scour in low water depths. The boats may need to work outside the actual boom area to move the logs into place and secure them. As the boats swing around, suspended sediments can be propelled away from their immediate working area. It is assumed that sections of the eelgrass beds may have be affected by prop scour or sediment smothering during boom boat activity. A few patches of eelgrass still survive and if there are
